Northern Ireland Motorcycle Fatality Report 2012

Indepth Study Of 39 Motorcycle Collisions In Northern Ireland Between
2004 And 2010 In Which 41 Motorcyclists Were Fatally Injured

Elaine Hardy, PhD

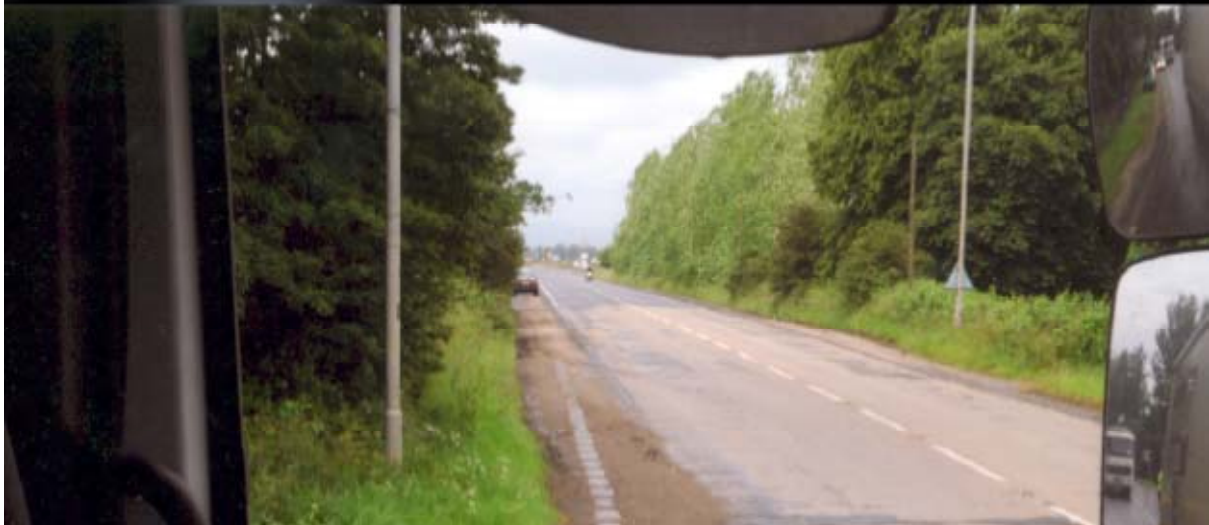
Photograph One: (Speed of 80 mph)

Below are photographs of the view at 231, 153 and 109 metres. The first indicates the position of the motorcycle when the truck commences to manoeuvre (8 seconds to complete) with the motorcycle at a speed of 80 mph, the second indicates the position of the motorcycle when the truck commences to manoeuvre (8 seconds to complete) with the motorcycle at a speed of 68 mph, the third indicates the position of the motorcycle when the motorcyclist perceived a hazard with the motorcycle at a speed of 80 mph.

VISIBILITY DISTANCE (231m)

The speed at the location of the collision was 40 mph, however according to the investigator the motorcycle had been travelling at a speed of at least 68 to 80 mph at the start of the tyre mark. The Highway Code states that the braking distance at 40 mph is 24 metres. Therefore if braking had been applied at the start of the tyre mark at 40 mph, it should have been possible to stop the motorcycle approx. 31 metres prior to the centre of the junction or 37 metres prior to the collision area.

According to the investigator, the motorcycle was being ridden on dipped beam illumination at the time of the collision, however as shown in the photographs above, the illuminated dipped beam headlight on a similar motorcycle does not significantly alter the visibility of the motorcycle in daylight when viewed from the inside of the truck at the end of the minor road. The illuminated headlight is much more apparent when viewed from a lower angle and when more closely aligned with the direction of travel of the motorcycle (see photograph four below).

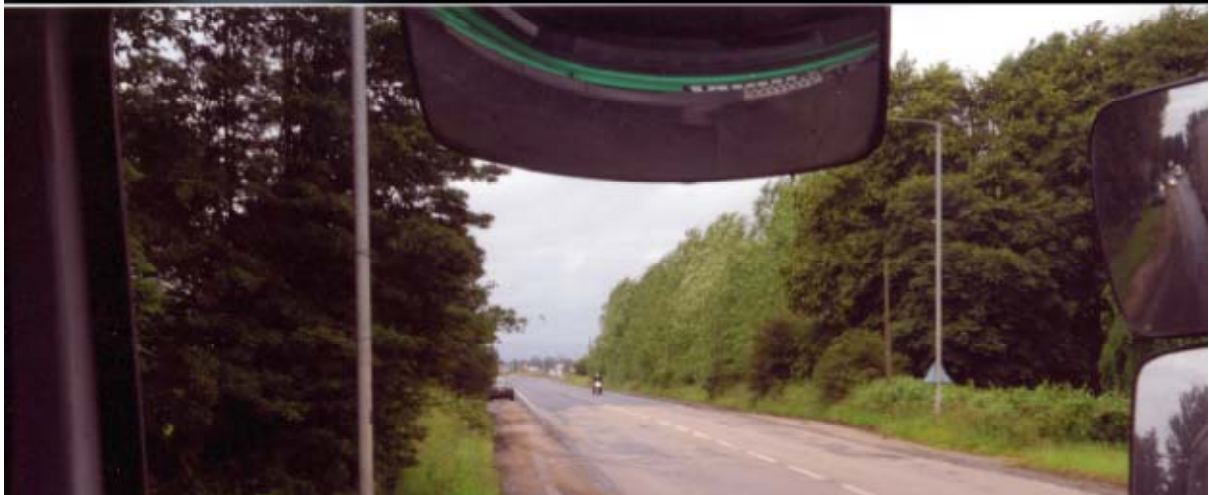
Photograph Two: (Speed of 68 mph)

VISIBILITY DISTANCE (153m)

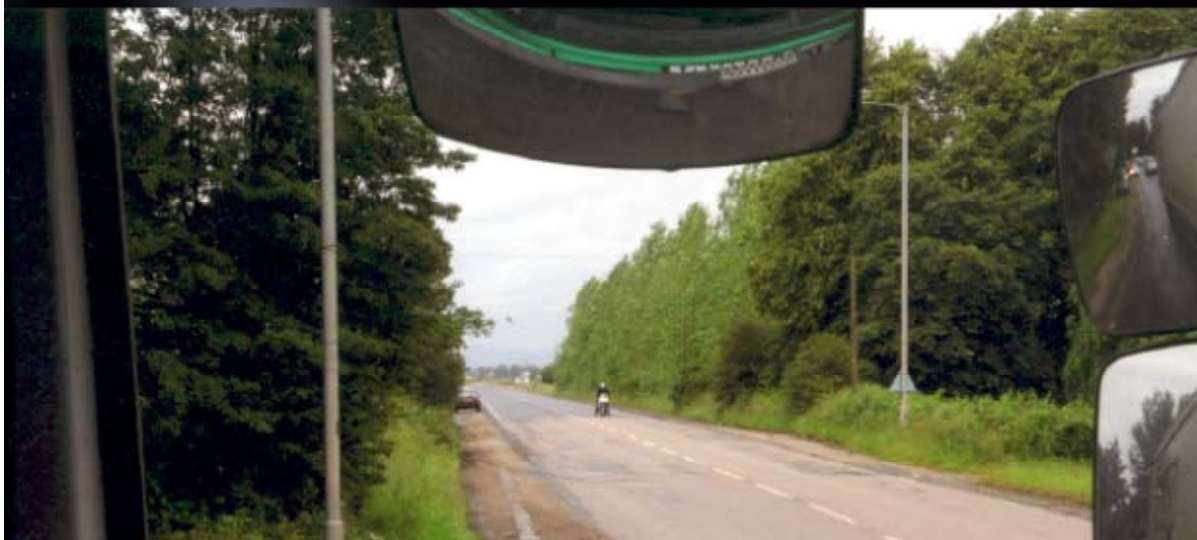
Photograph Three: (perceived a hazard with the motorcycle at a speed of 80 mph)

VISIBILITY DISTANCE (109m)
